# **114 Fabricated Mechanical Joint Repair Sleeves**

# 114 Fabricated Mechanical Joint Repair Sleeves For familiar cast iron and ductile iron problems.

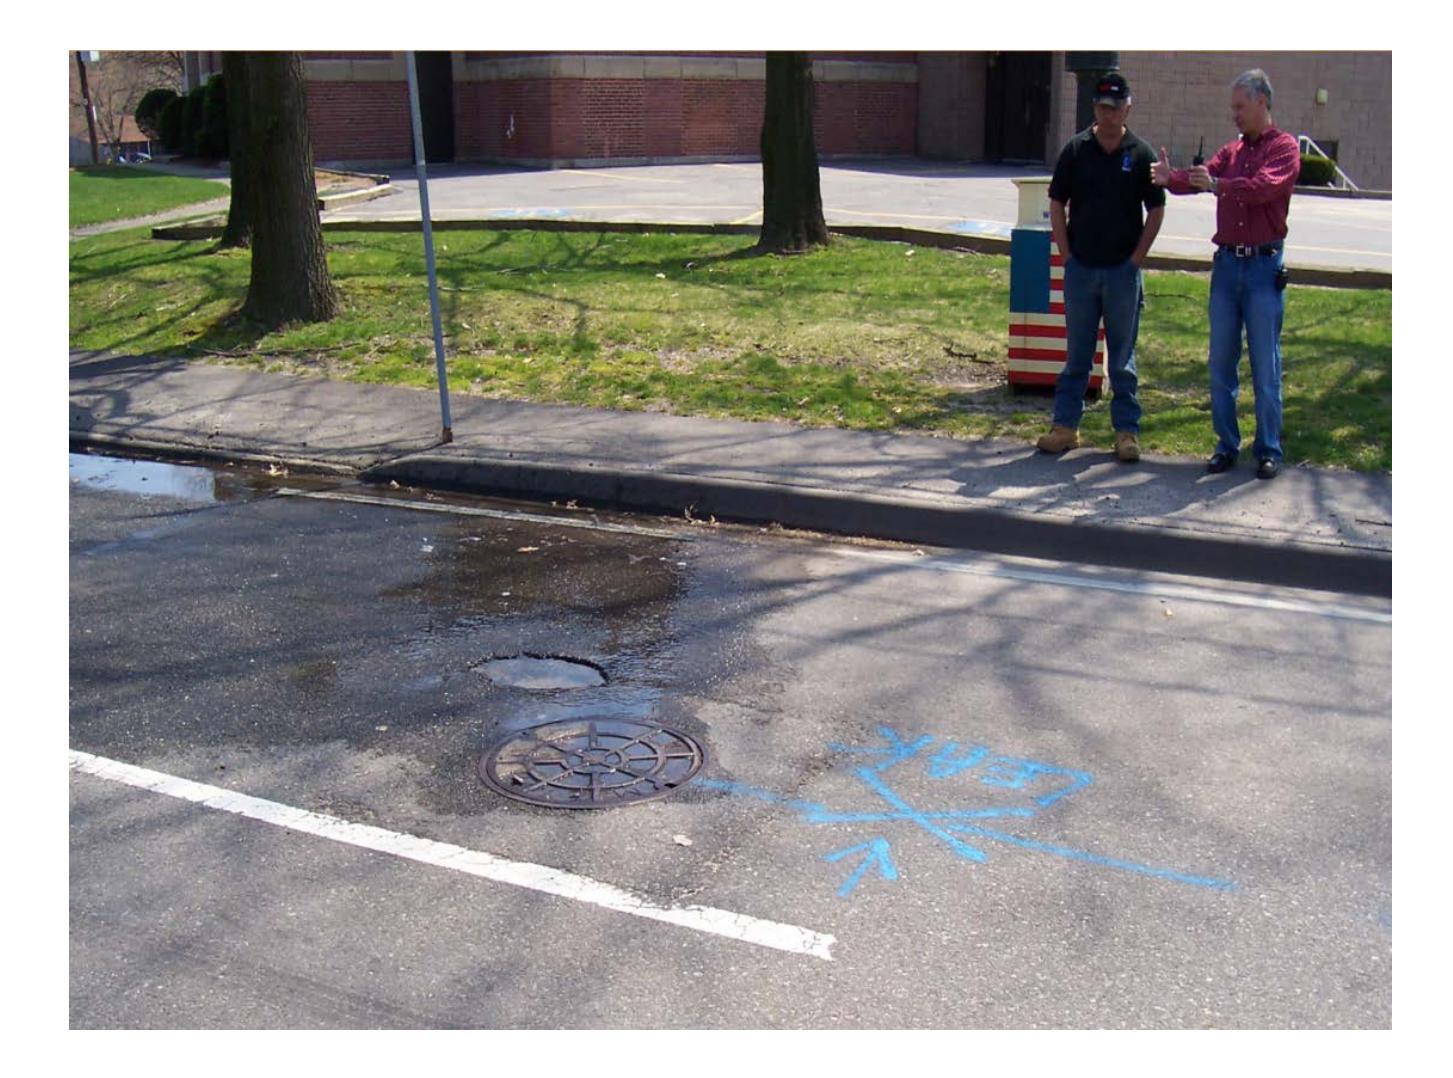
JCM 114 Bell Repair Sleeve Bell – Spigot Connection JCM 114 Bell Repair Sleeve Flanged Pipe Connection JCM 114 Repair Sleeve Repair Straight Run of Pipe Boston, Massachusetts Leaking 60" Cast Iron Bell-Spigot Joint One of two major transmission mains serving suburban areas.

Boston, Massachusetts Leaking 60" Cast Iron Bell-Spigot Joint Mechanical Bell Join Leak Clamp installed in early 1970's extended service life for 30+ years. Fitting failure required repair.

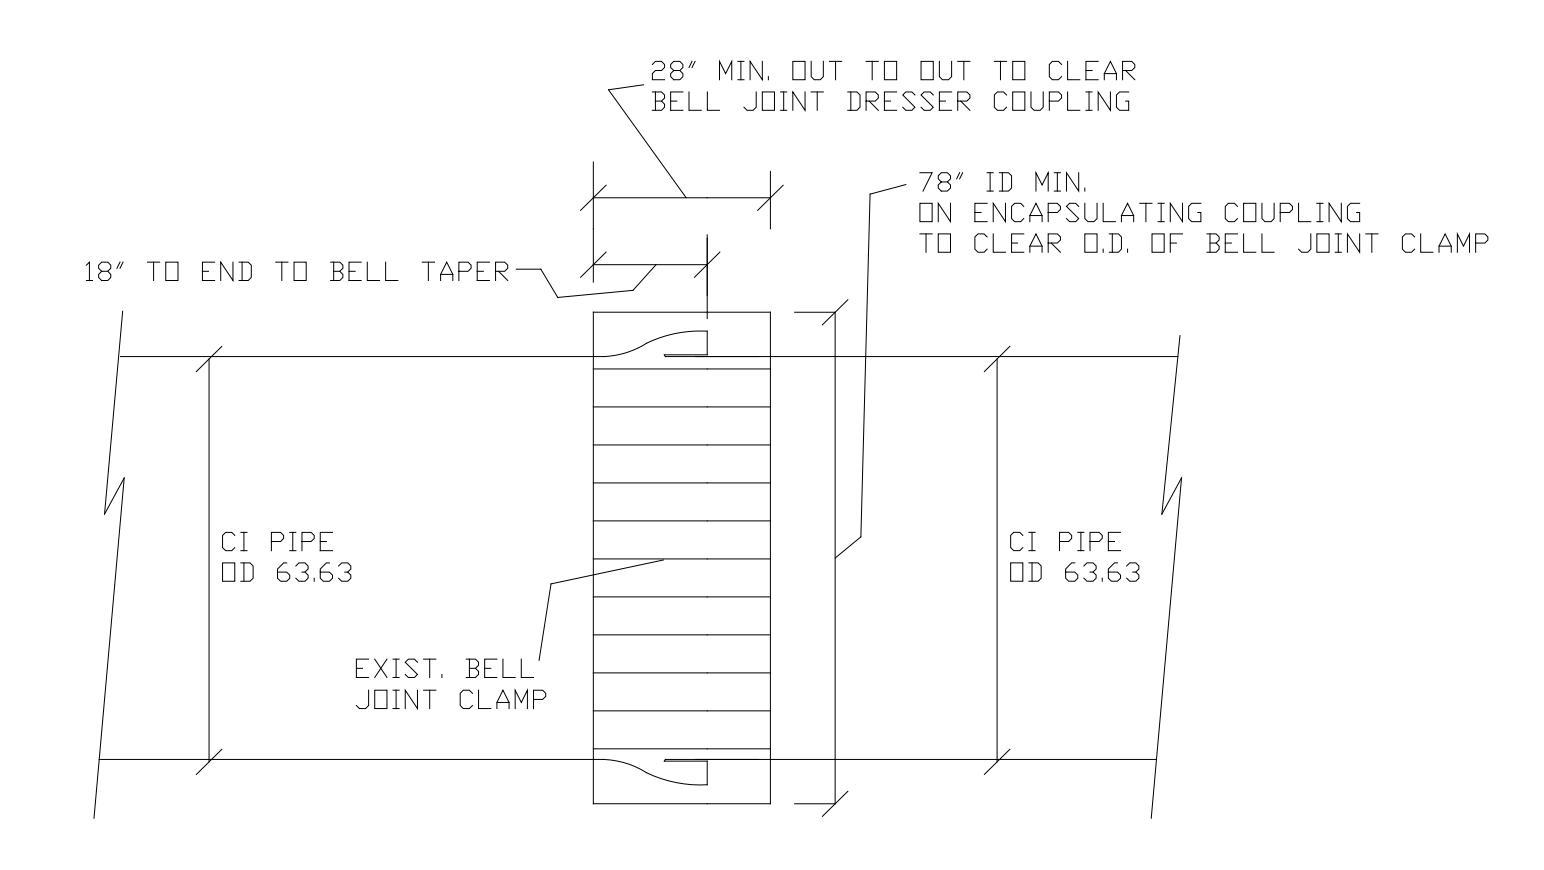
- Cast iron pipeline: 63.63 O.D.
- Cast bell joint: 78.00 O.D.
- Bell length w/clamp: 28" long
- Working pressure: 150 PSI

SHOWN ABOVE: EXISTING DIMENSIONS OF LEAKING BELL JOINT. MAIN CANNOT BE ISOLATED THEREFORE MWRA NEEDS AN ENCAPSULATING COUPLING TO ENVELOPE AROUND THE EXISTING BELL AND BELL JOINT CLAMP BOTH SIDES OF ENCAPSULATION FITTING TO GO FROM 63.63 O.D. ON EXISTING PIPE TO 78" I.D. IN THE MIDDLE FOR A MINIMUM OF 28" LENGTH TO CLEAR THE EXISTING BELL JOINT CLAMP NOTE ALSO THAT ENCAPSULATION FITTING TO HAVE BLEED-OFF PLUG OR CORPORATION FOR EASE OF INSTALLATION JCM responds to the inquiry with the JCM 114 Mechanical Joint Bell Repair Sleeve. This drawing submitted to the MWRA for consideration.

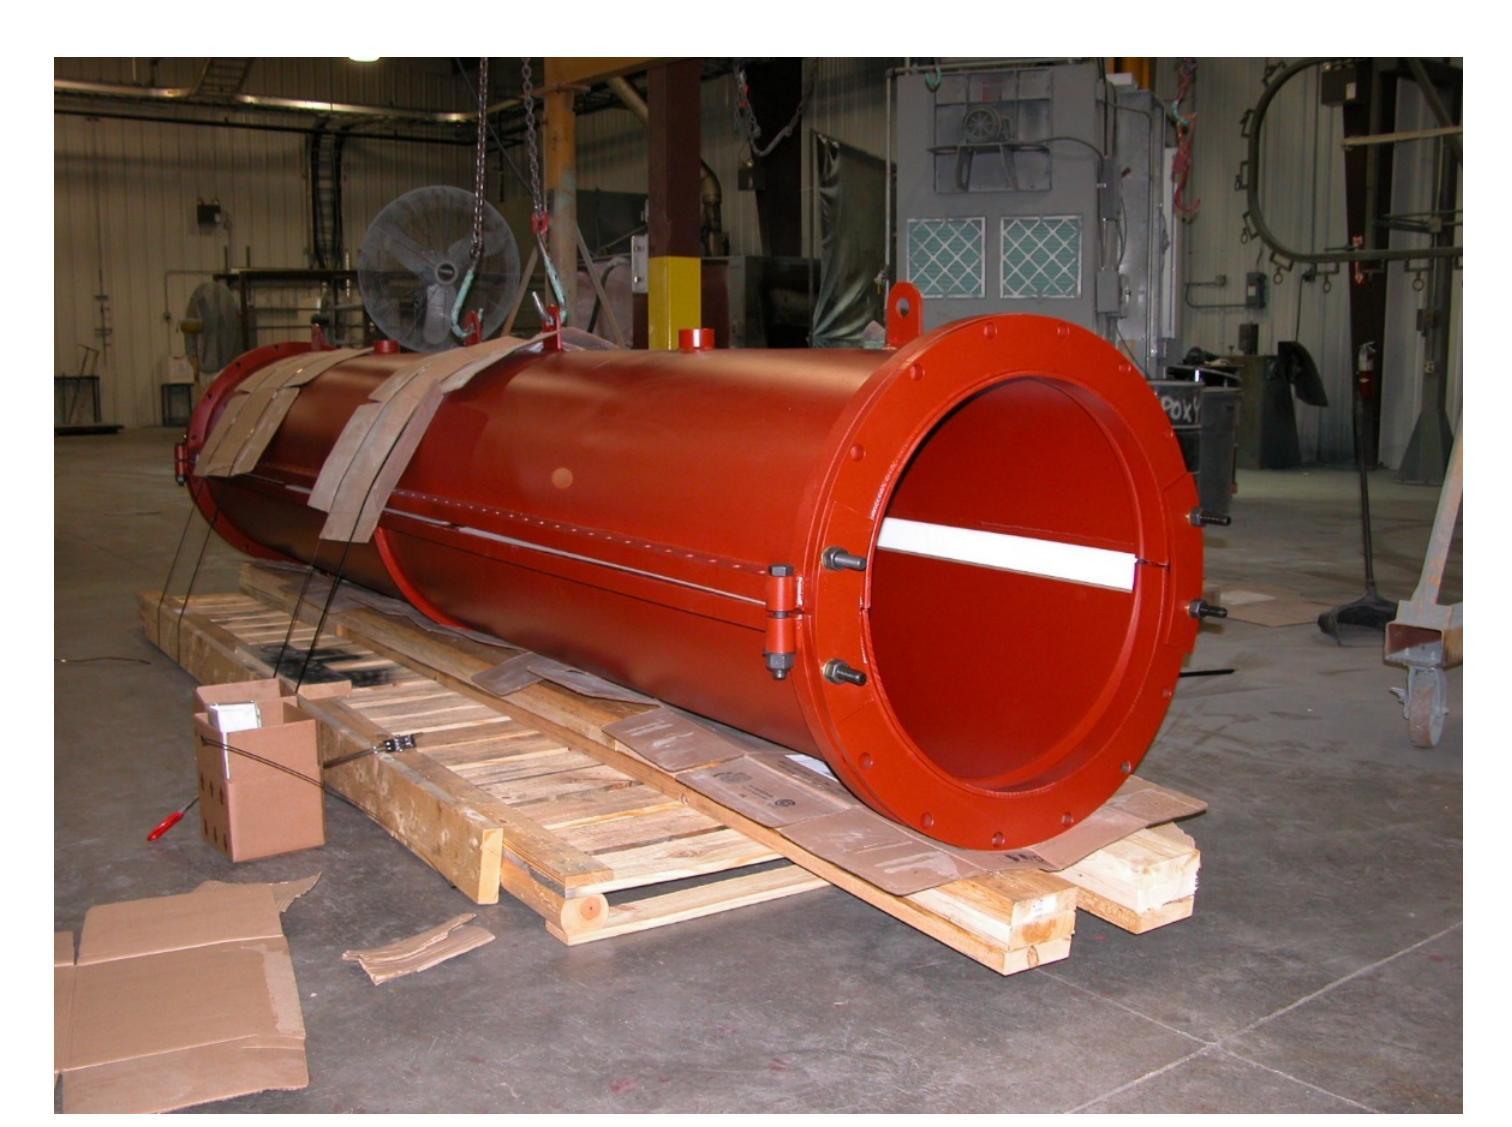
PROBLEM: Underwater 30" Cast Iron Pipe about 100 years old. Galveston Island water supply from City of Houston. Numerous leaks and breaks, old valves and growing demands put enormous stress on the older line. *Note the temporary JCM Universal Clamp Couplings.*

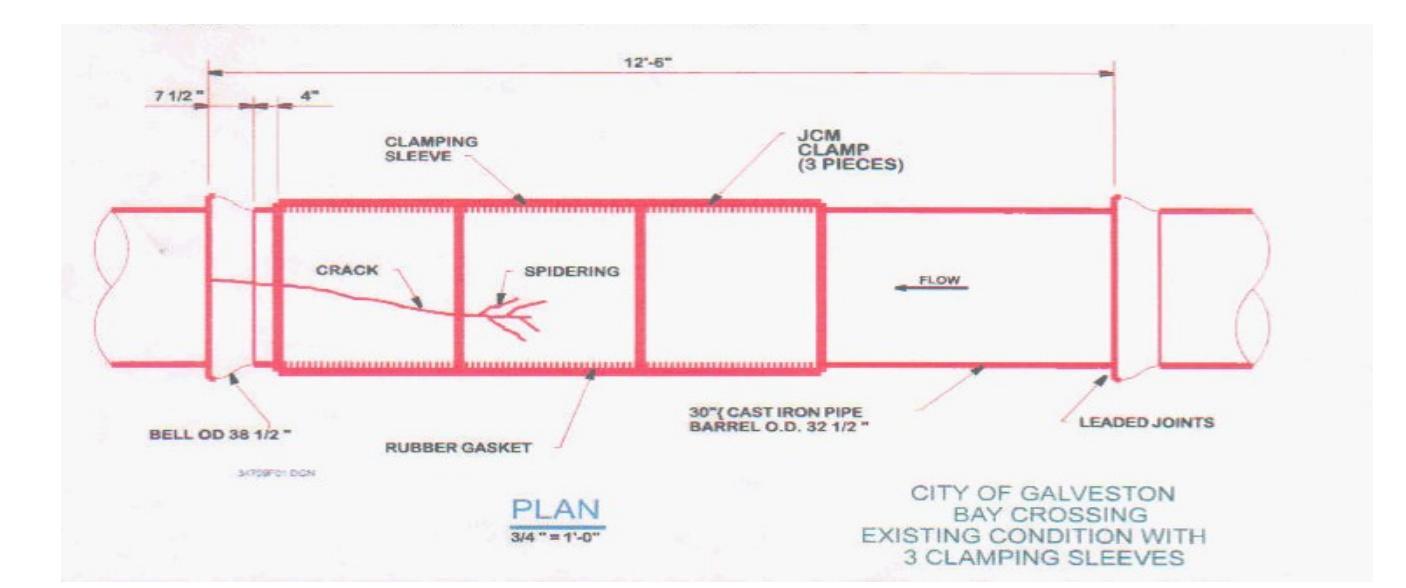
SCALE: 3/8 \* = 1'-0\* 2" BALL DAMAGED BELL (32 1/2 " O.D.) 48" STEEL SLEEVE 30" CAST IRON PUSHER PLATE, TYP WATER MAIN PTP FIG. 190 CLAMP (2 EA. PILE TYP) 3" WELD, BOTH SIDES, TYP SAND/CEMENT BAGS, TYP 6" DIA. PILE (TYP BOTH SIDES) 34709F06.DGN FINAL SLEEVE CONFIGURATION

After – green outline represents fabricated fitting. Encompasses two joints and full length of pipe.

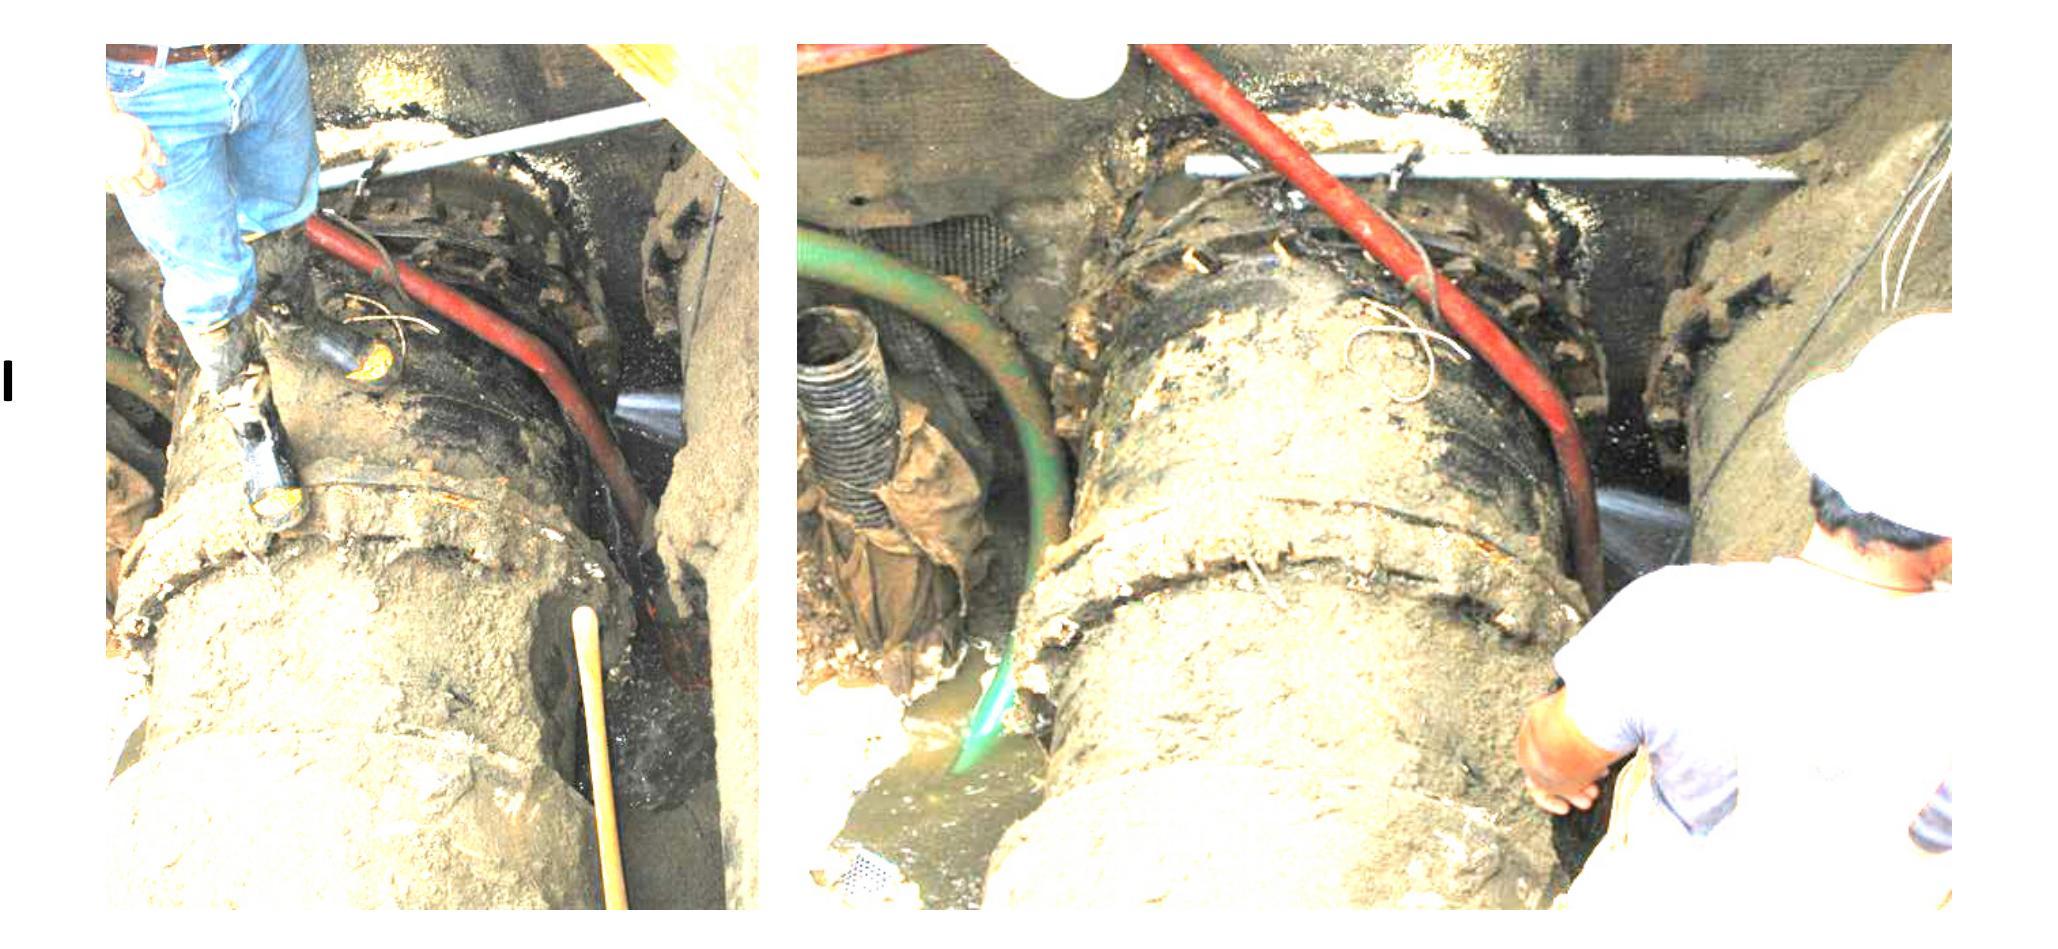
Leaking 30" DI MJ x MJ Fitting

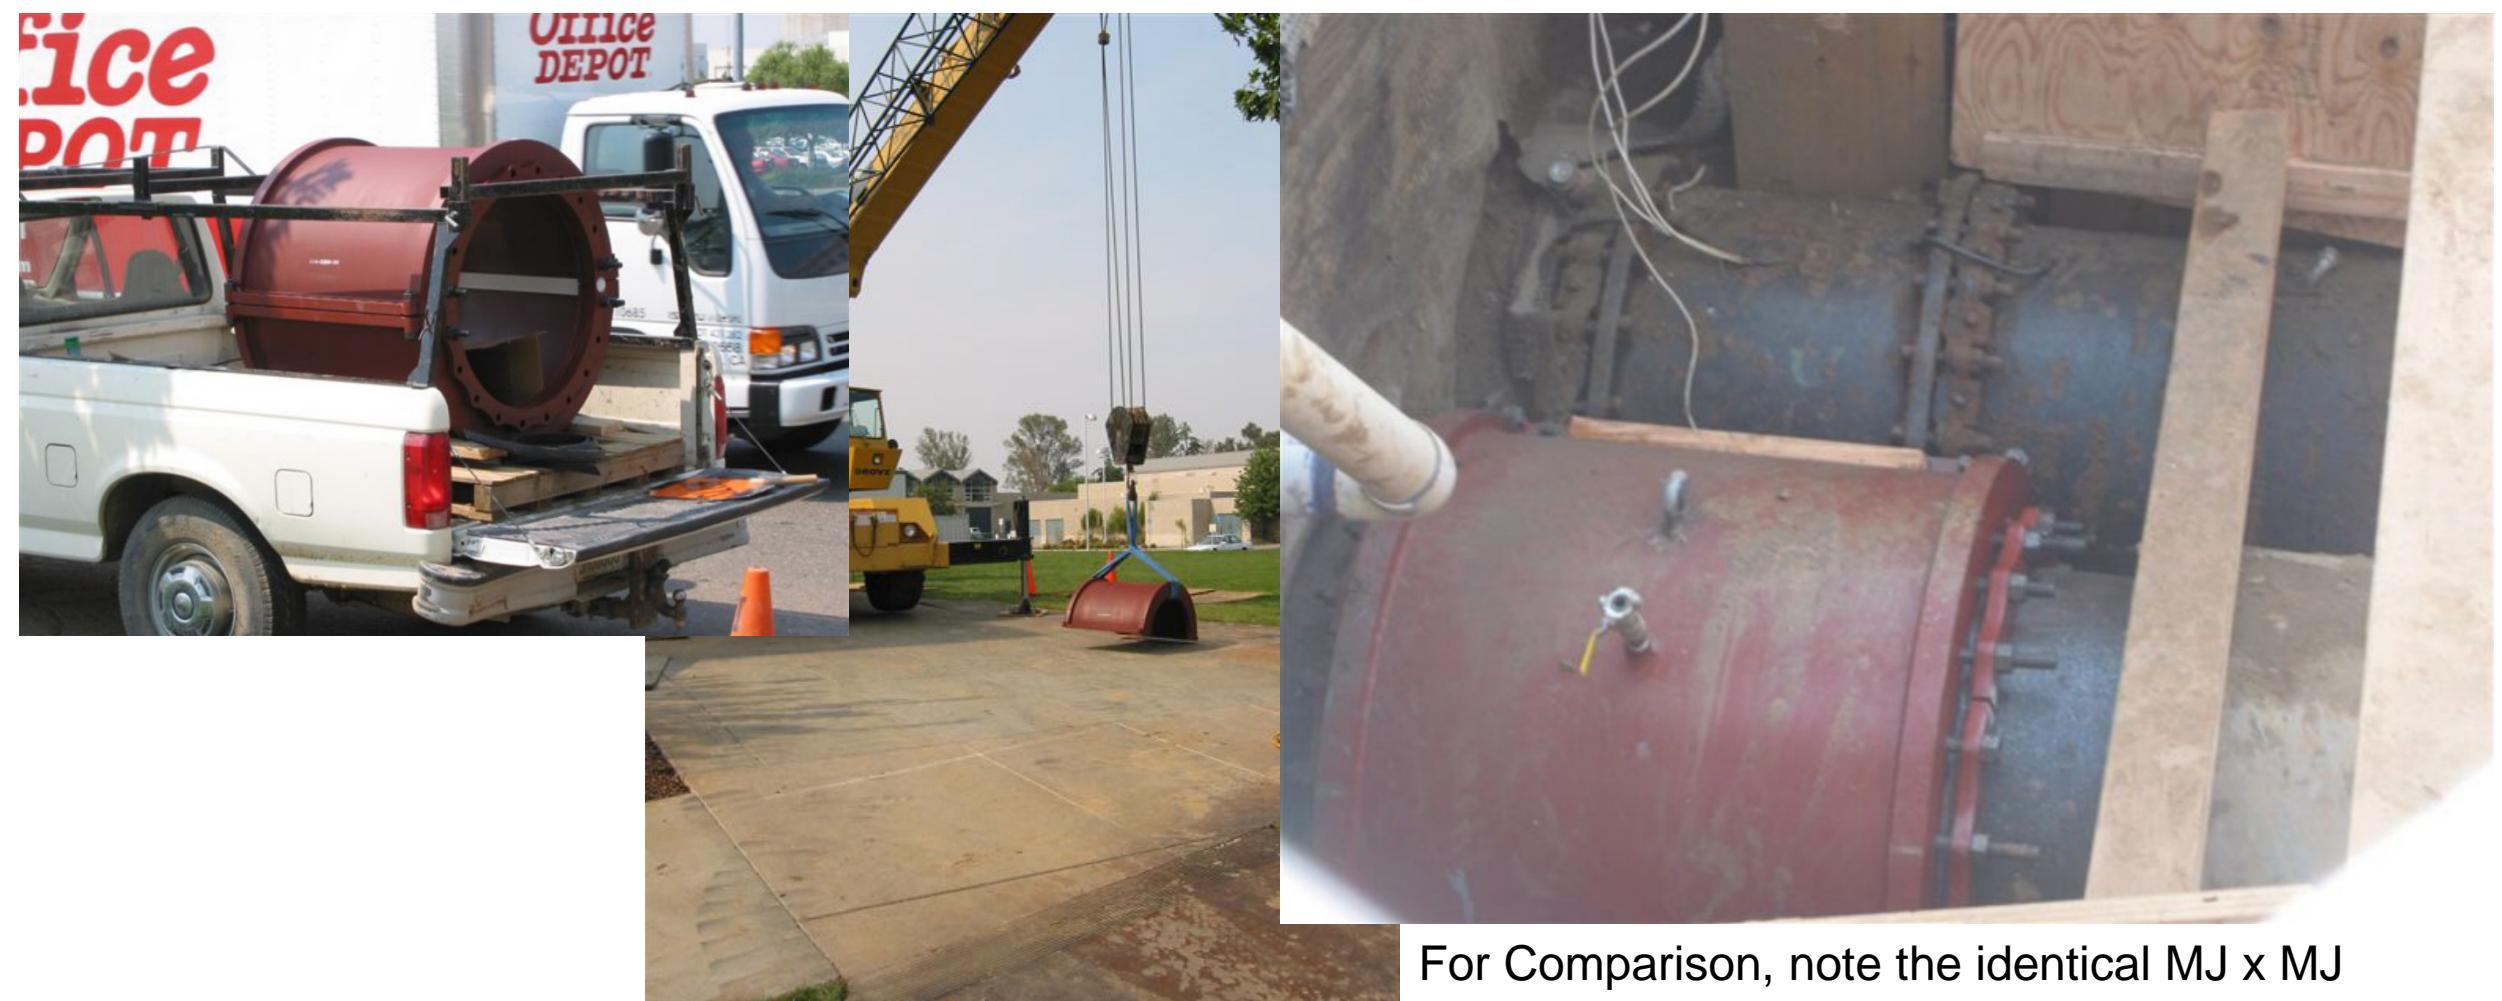
For Comparison, note the identical MJ x MJ Adapter just above the already installed JCM 114 Repair Sleeve

### JCM 114 Installed over Ductile MJ x MJ Adapter
