# **114 Fabricated Mechanical Joint Repair Sleeves**

# 114 Fabricated Mechanical Joint Repair Sleeves For familiar cast iron and ductile iron problems.

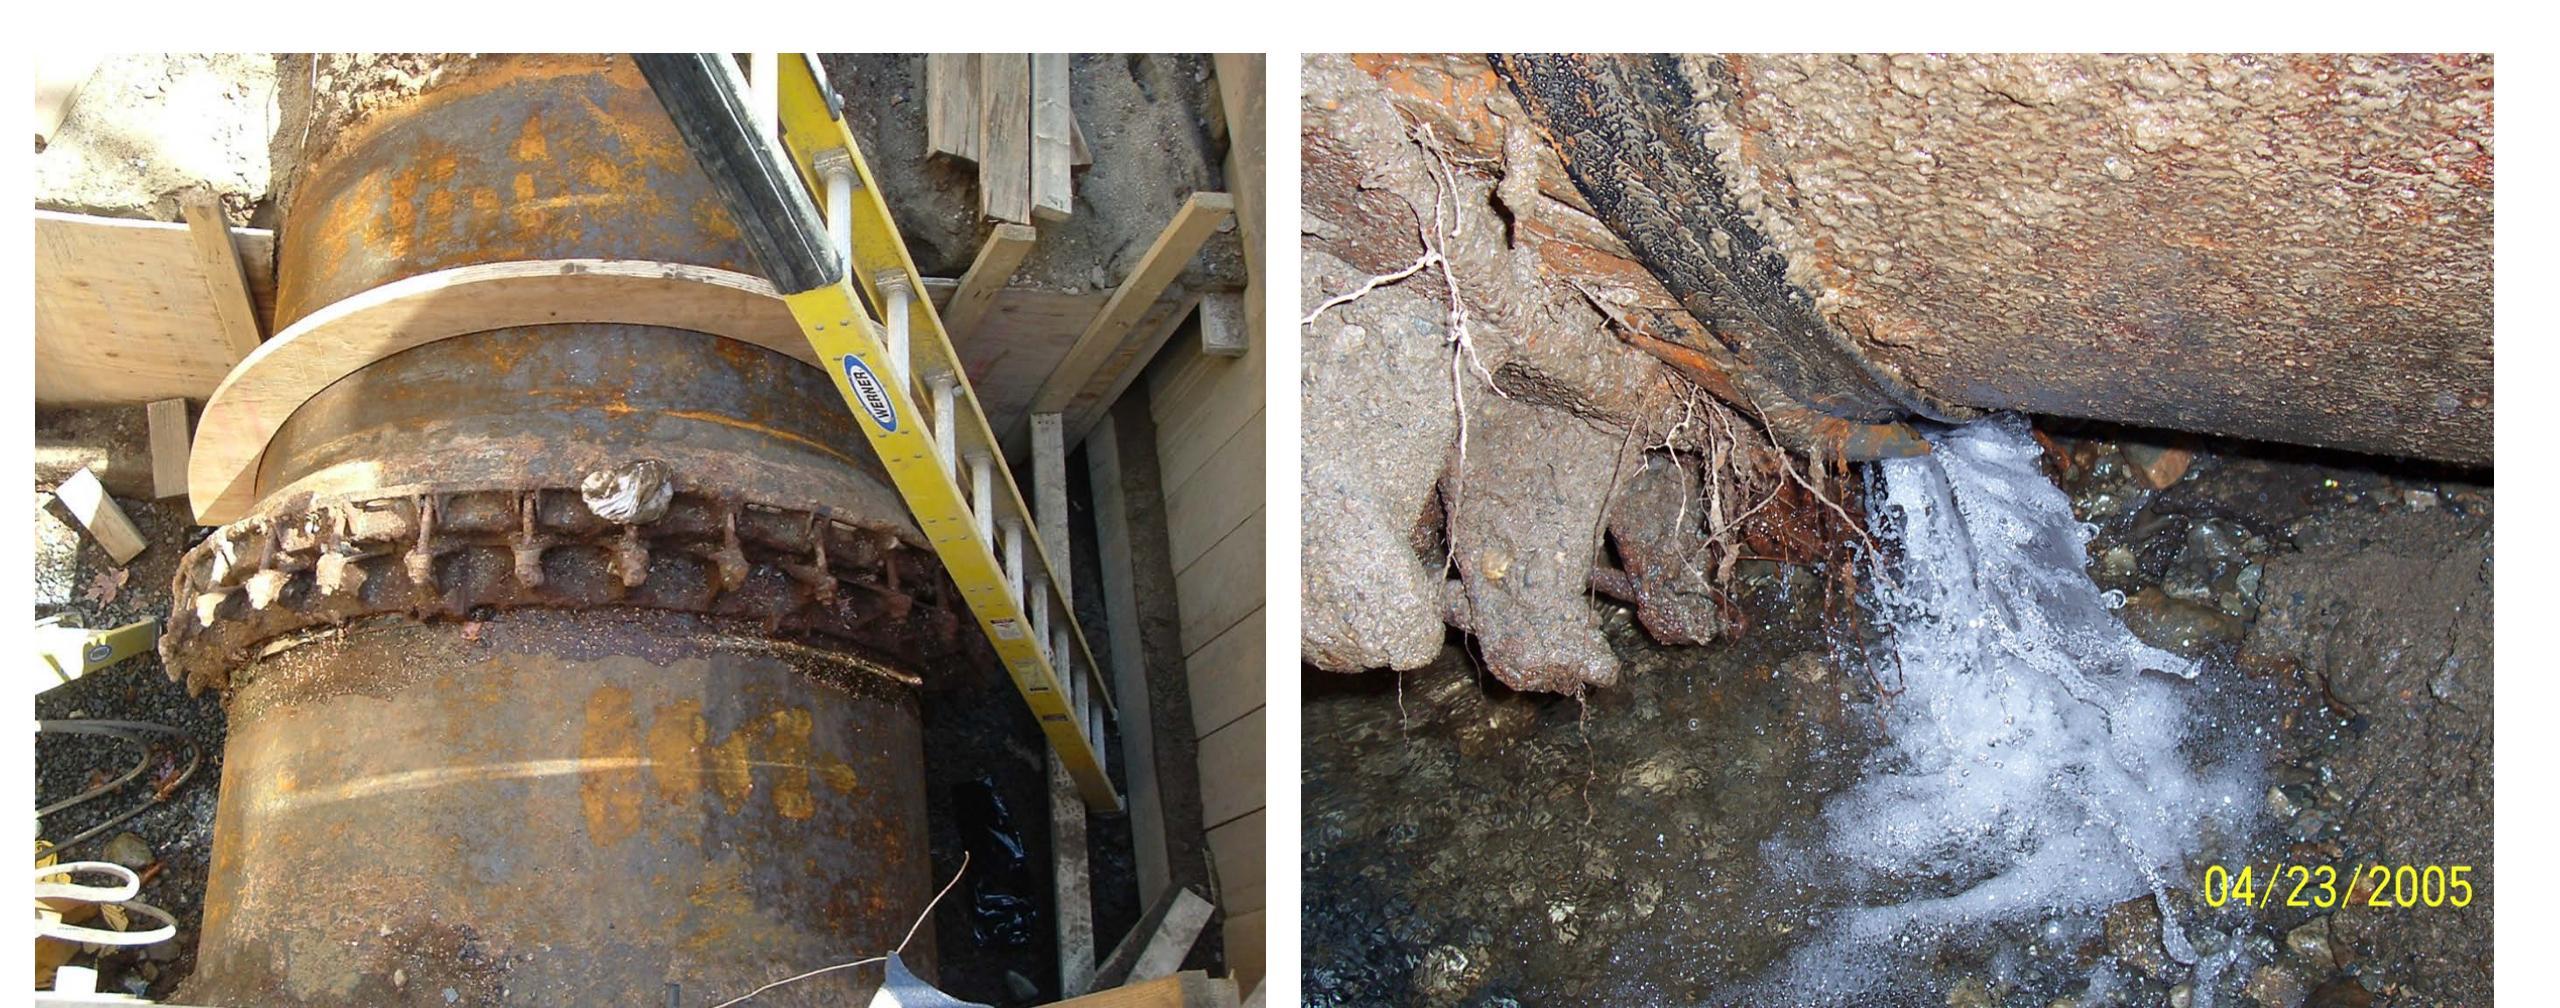
Boston, Massachusetts Leaking 60" Cast Iron Bell-Spigot Joint Mechanical Bell Join Leak Clamp installed in early 1970's extended service life for 30+ years. Fitting failure required repair.

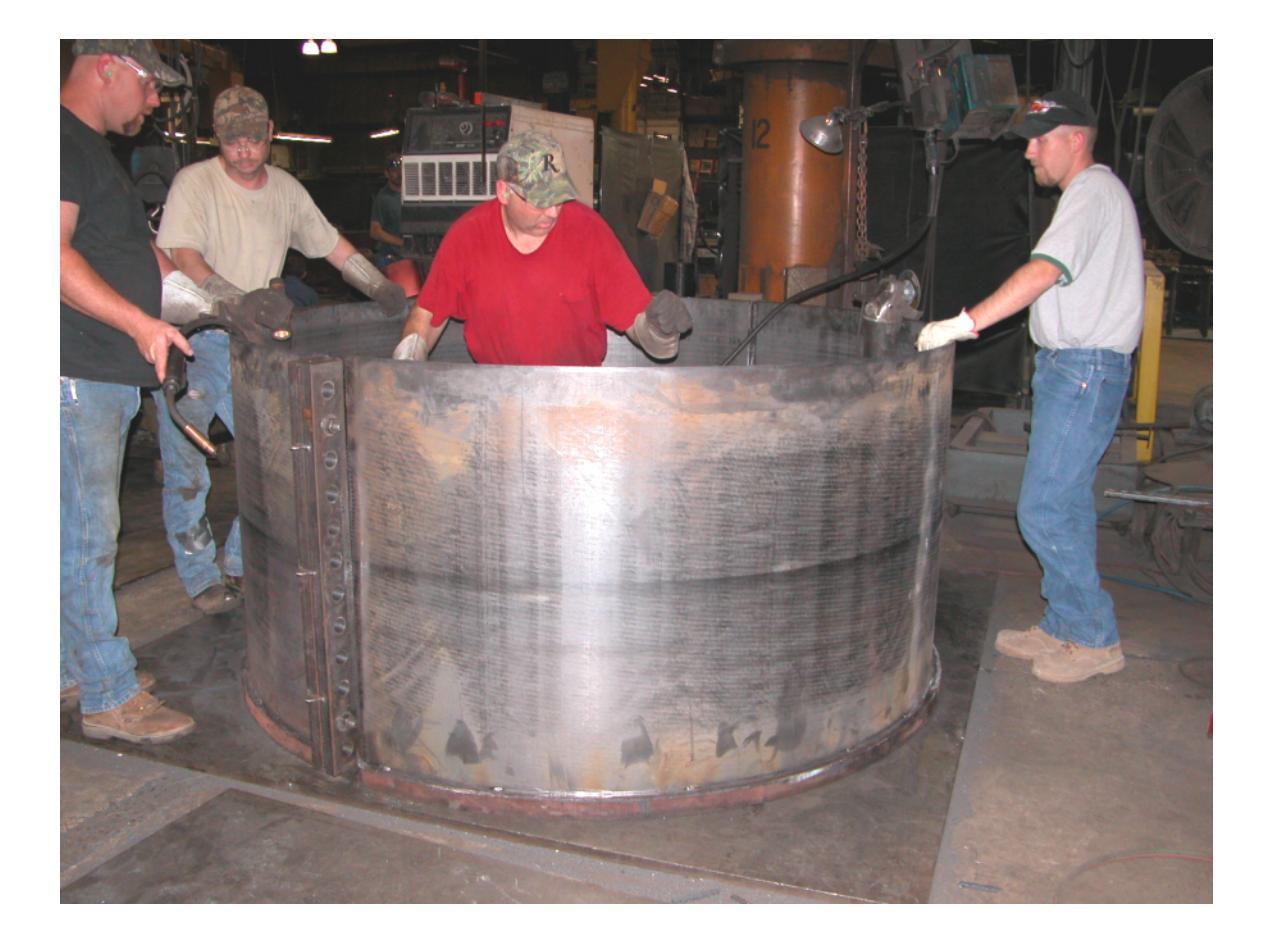
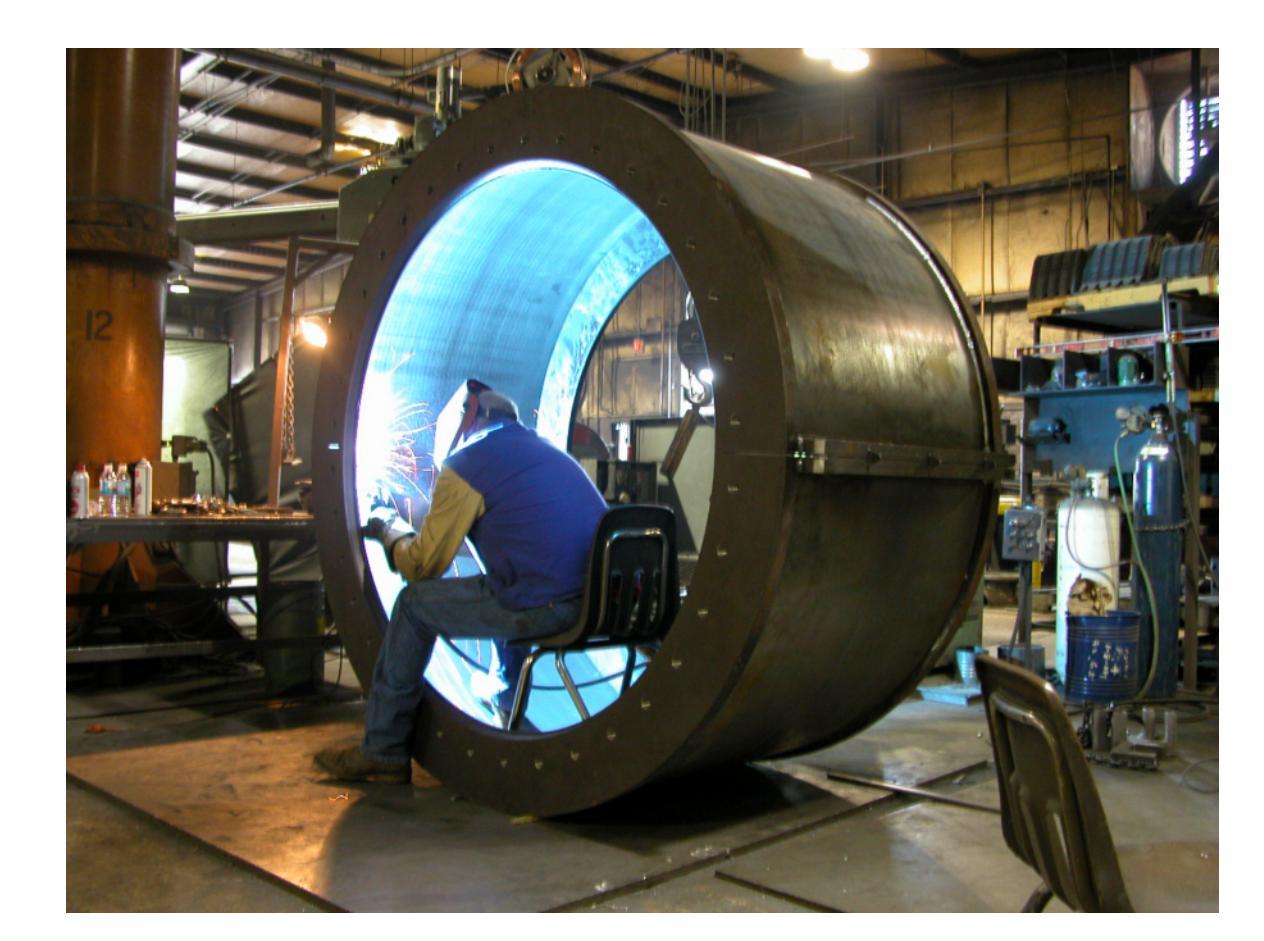
MWRA approved the submittal and placed order with JCM Industries on Tuesday, April 26. Several aspects concerning old, large diameter pipe were covered including: out of round condition, irregular pipe surface and extreme capabilities of the fabricated fitting. Special instructions for emergency status fabrication and shipment were included. JCM Industries order the special materials for fabricating a 60" fitting – body material, flanges, mechanical joint push rings, side lug bar material, etc. Materials were received and production on the fitting began on Thursday, April 28<sup>th</sup>.

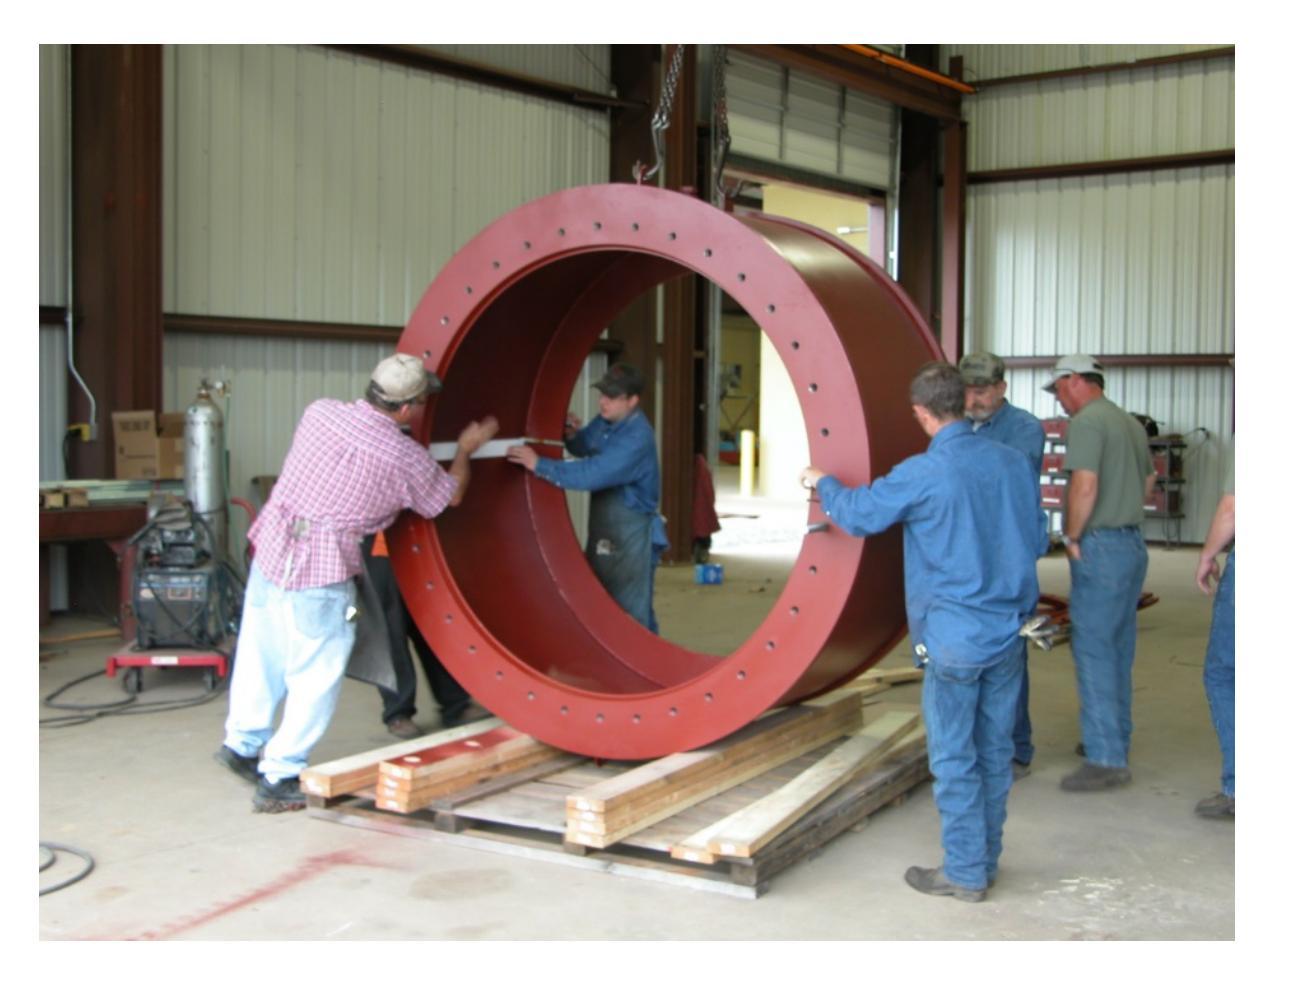
After fabrication and coating, the fitting is delivered to assembly for gasket installation, hardware and assembly for shipment.

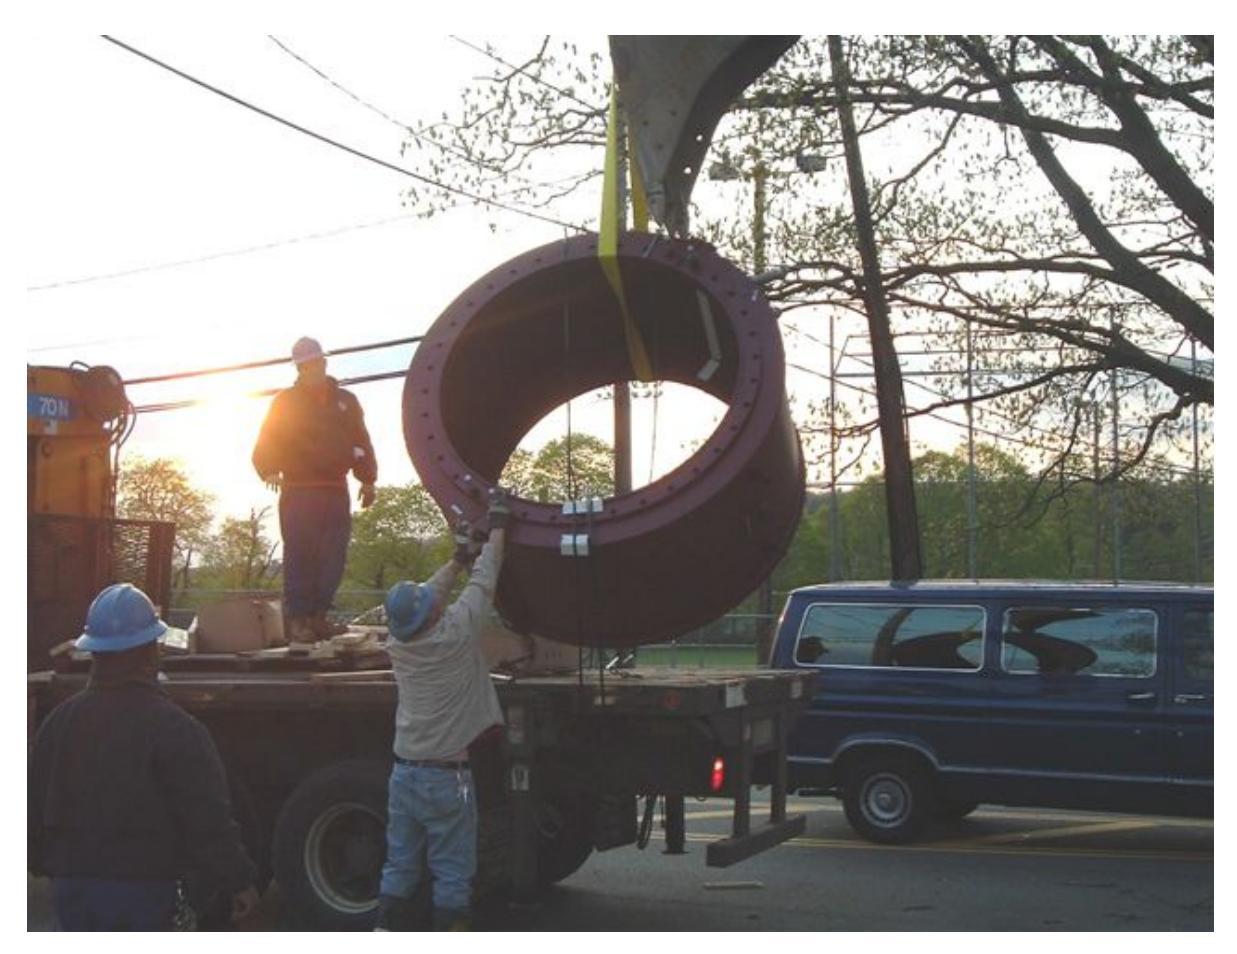
Fitting weight Approx. 6,500 lbs.

Fitting shipped on Friday, April 29th

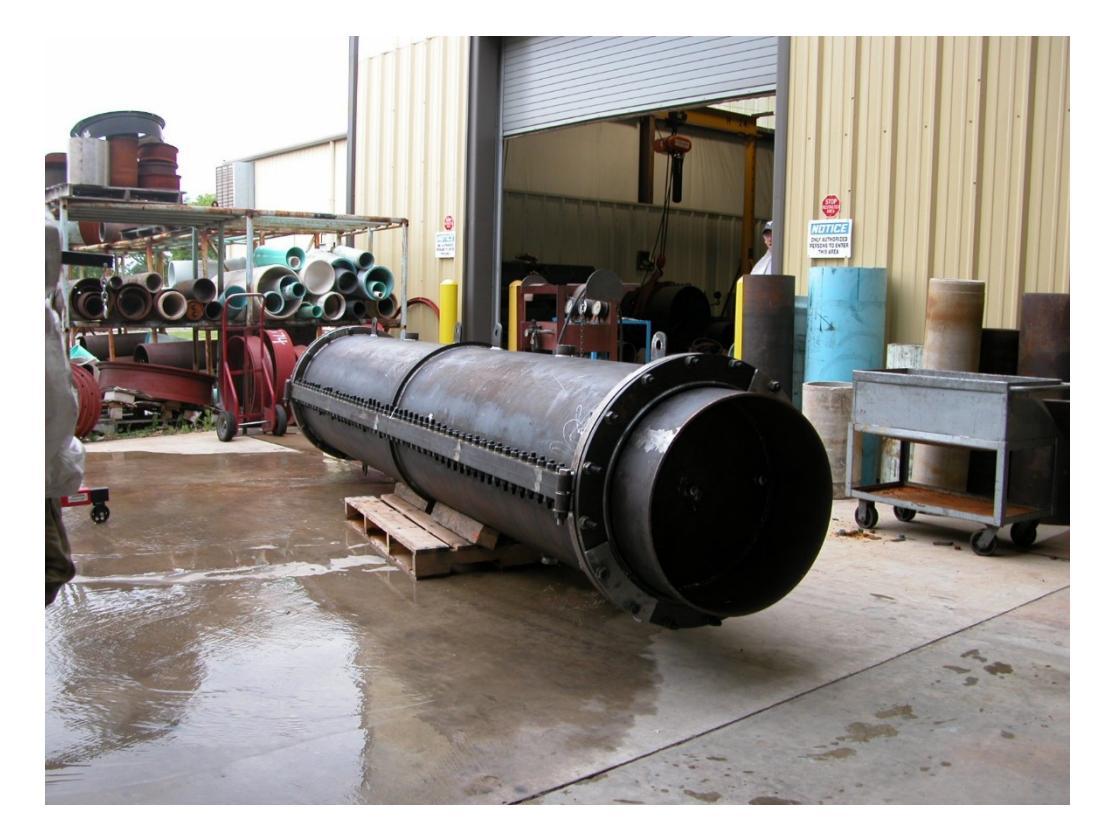
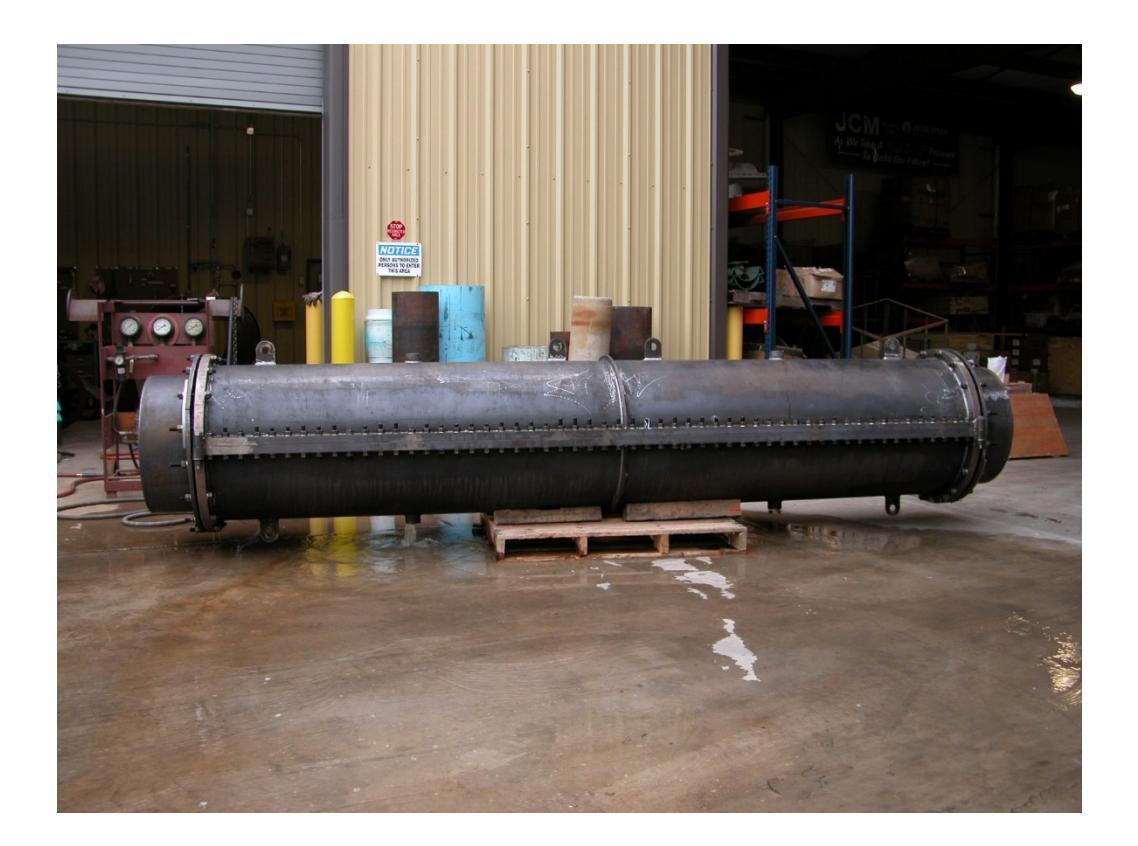
Pearl Harbor, Hawaii

Fitting installed on test fixture to ensure the integrity of the welds and construction.

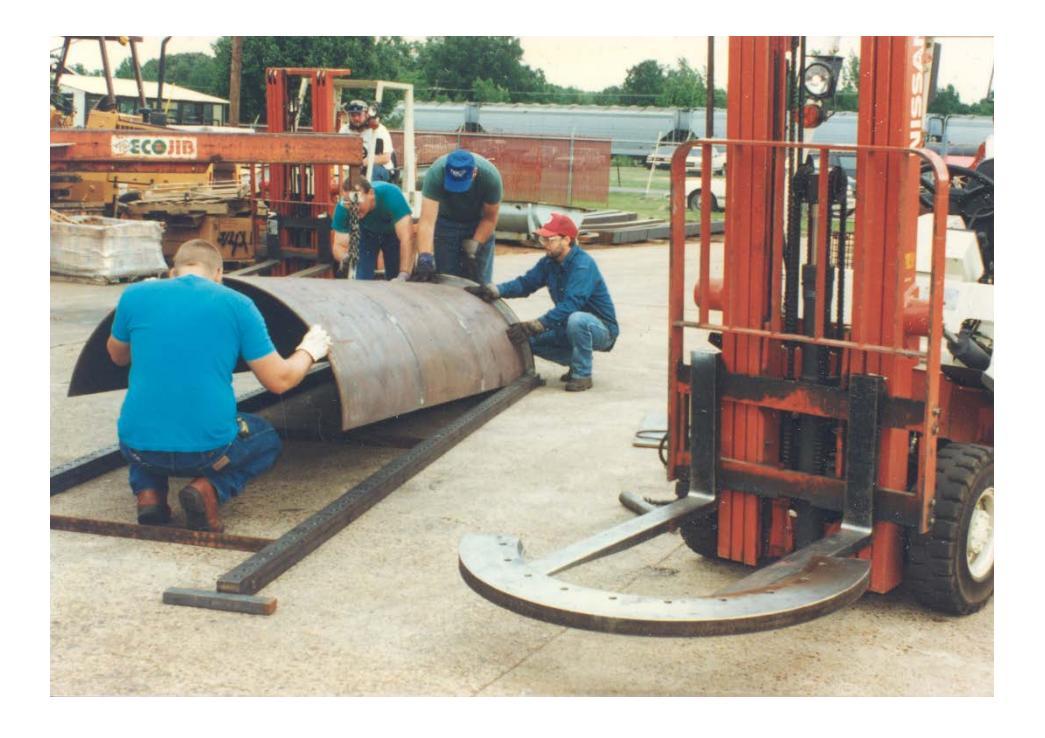
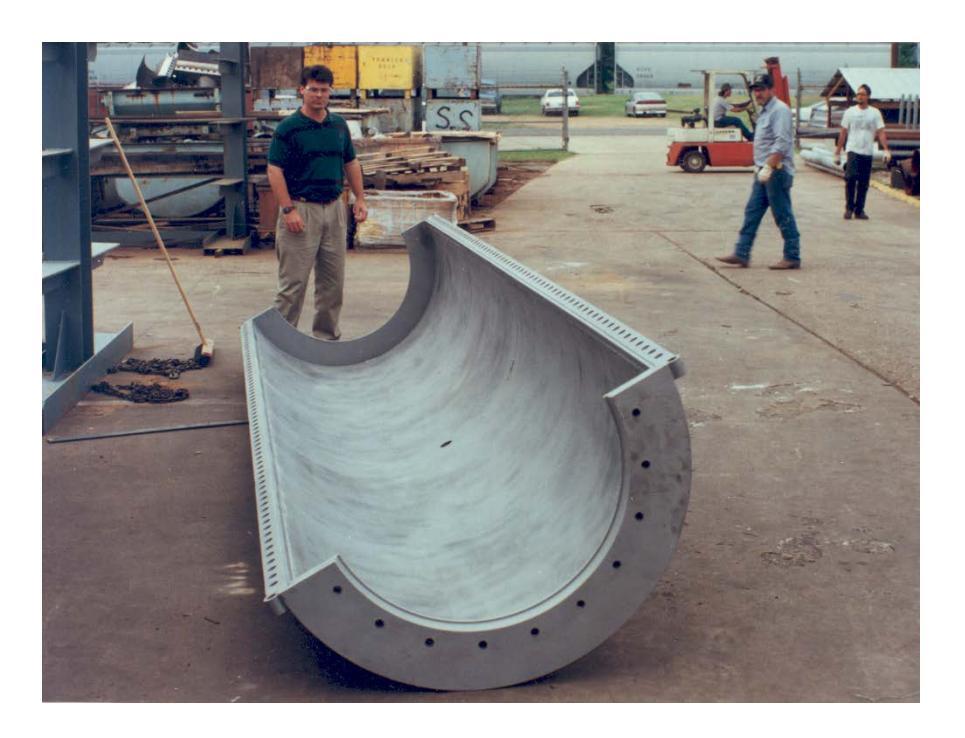
JCM submitted a custom fabricated 114 MJ Repair Sleeve to isolate the entire section of pipeline and permanently seal the damaged areas. JCM fabricators laying out the 16' long fitting.

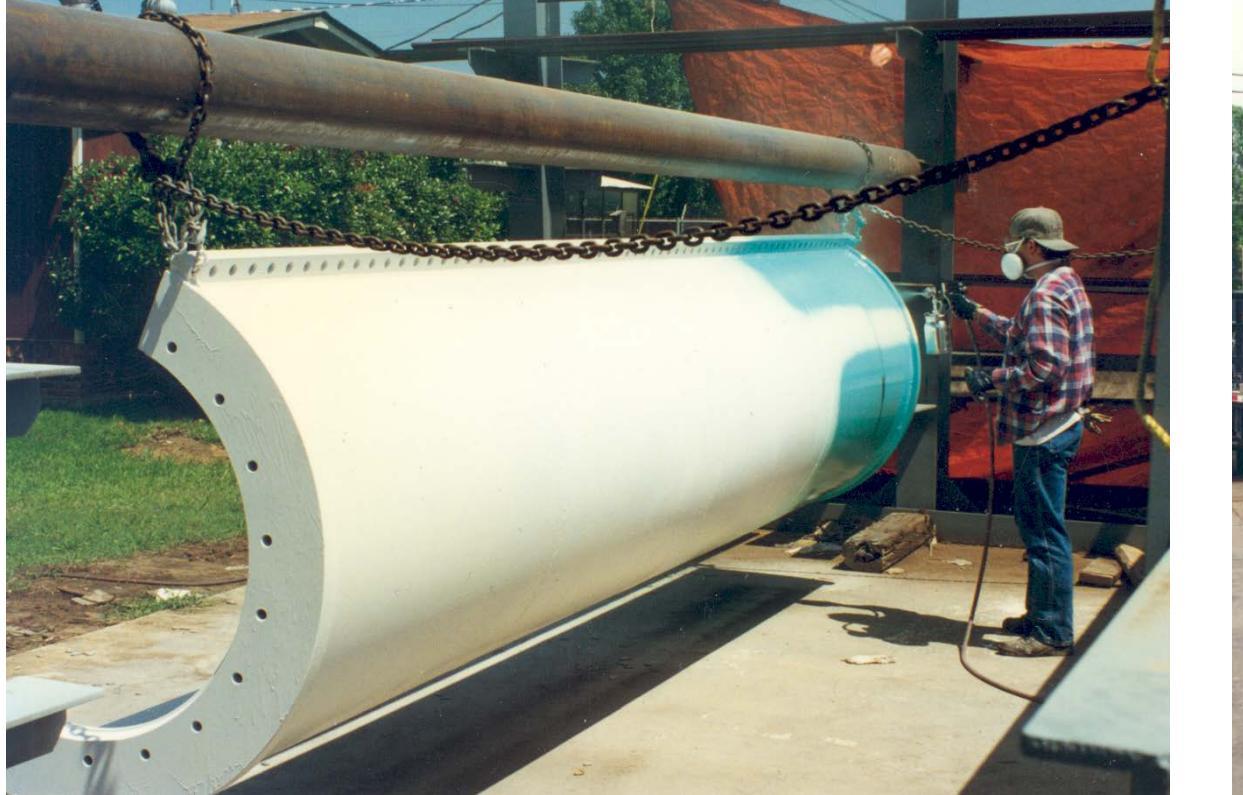
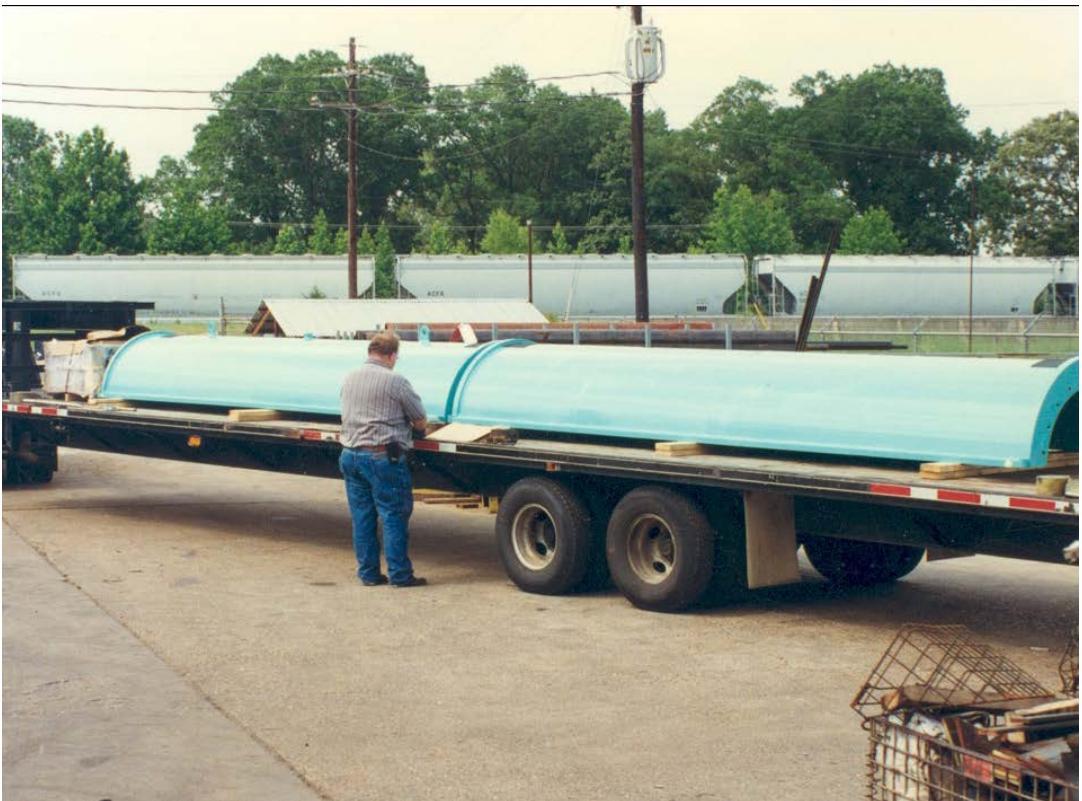
At completion of fabrication. Note the interior of the sleeve and the broad flange faces on the ends. This 114 was sized to accommodate the two Bells (O.D. of 38-1/2"). The 114 was provided with a epoxy coating and stainless steel hardware to protect the carbon steel from corrosive saltwater environment.

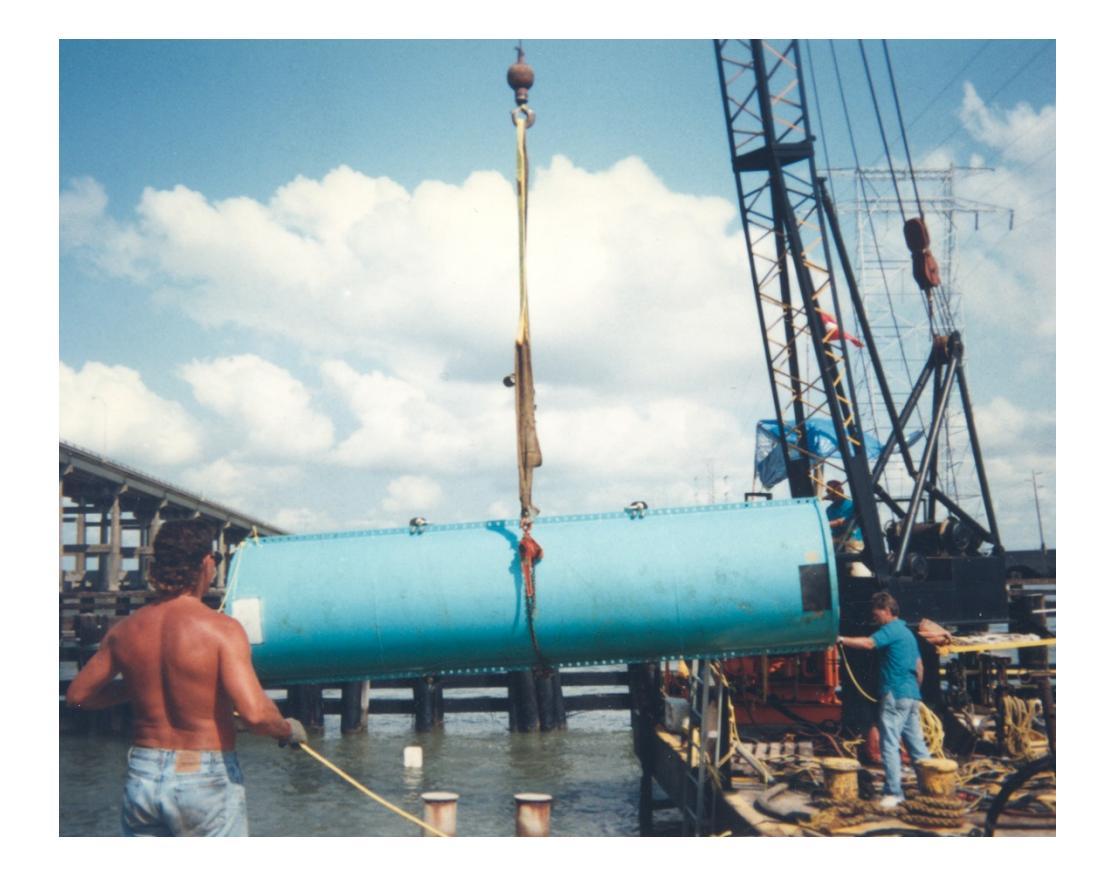
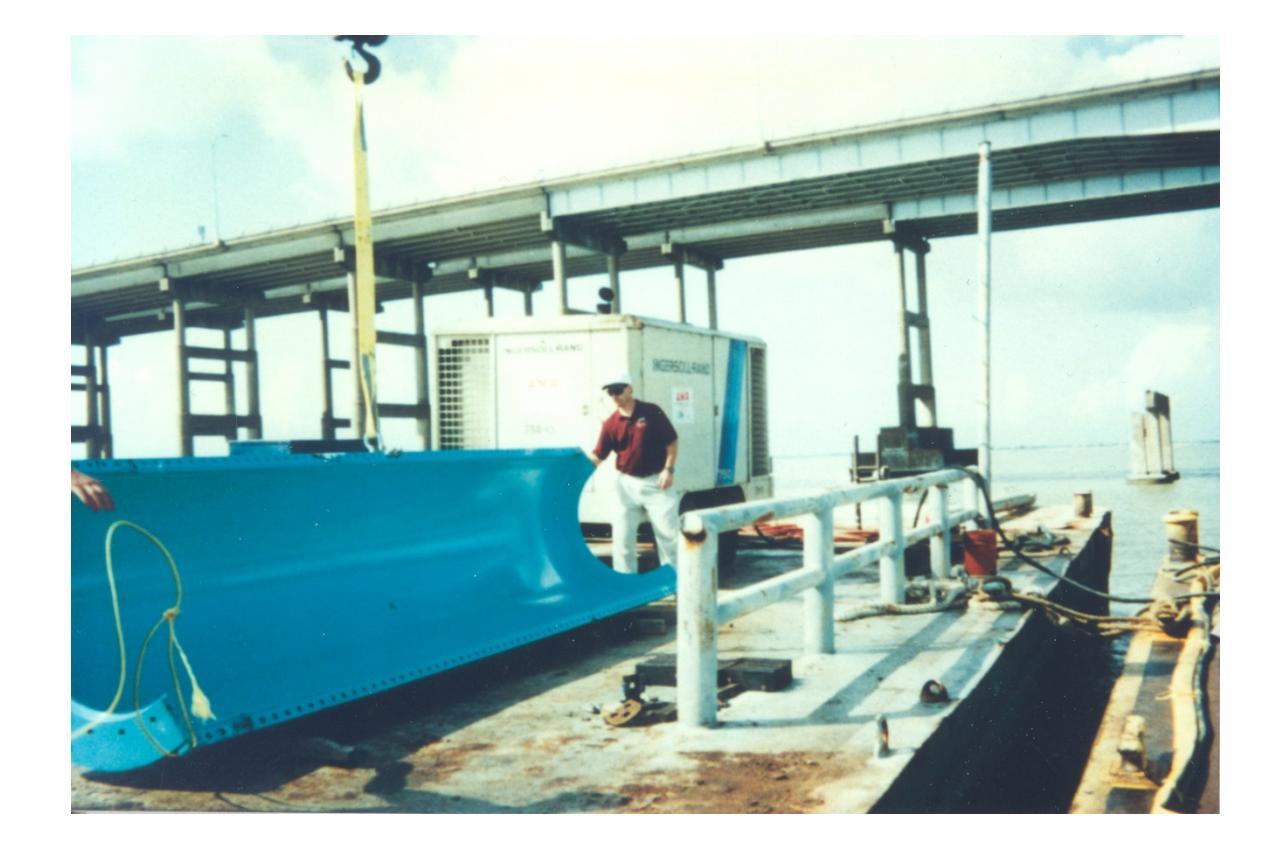
On the job site in Galveston, Texas. Installation crews used barges and large cranes to transport the fittings and drop them underwater for diver installation. (Installation project was delayed for two days waiting for Willie Nelson Concert on Galveston Island.)

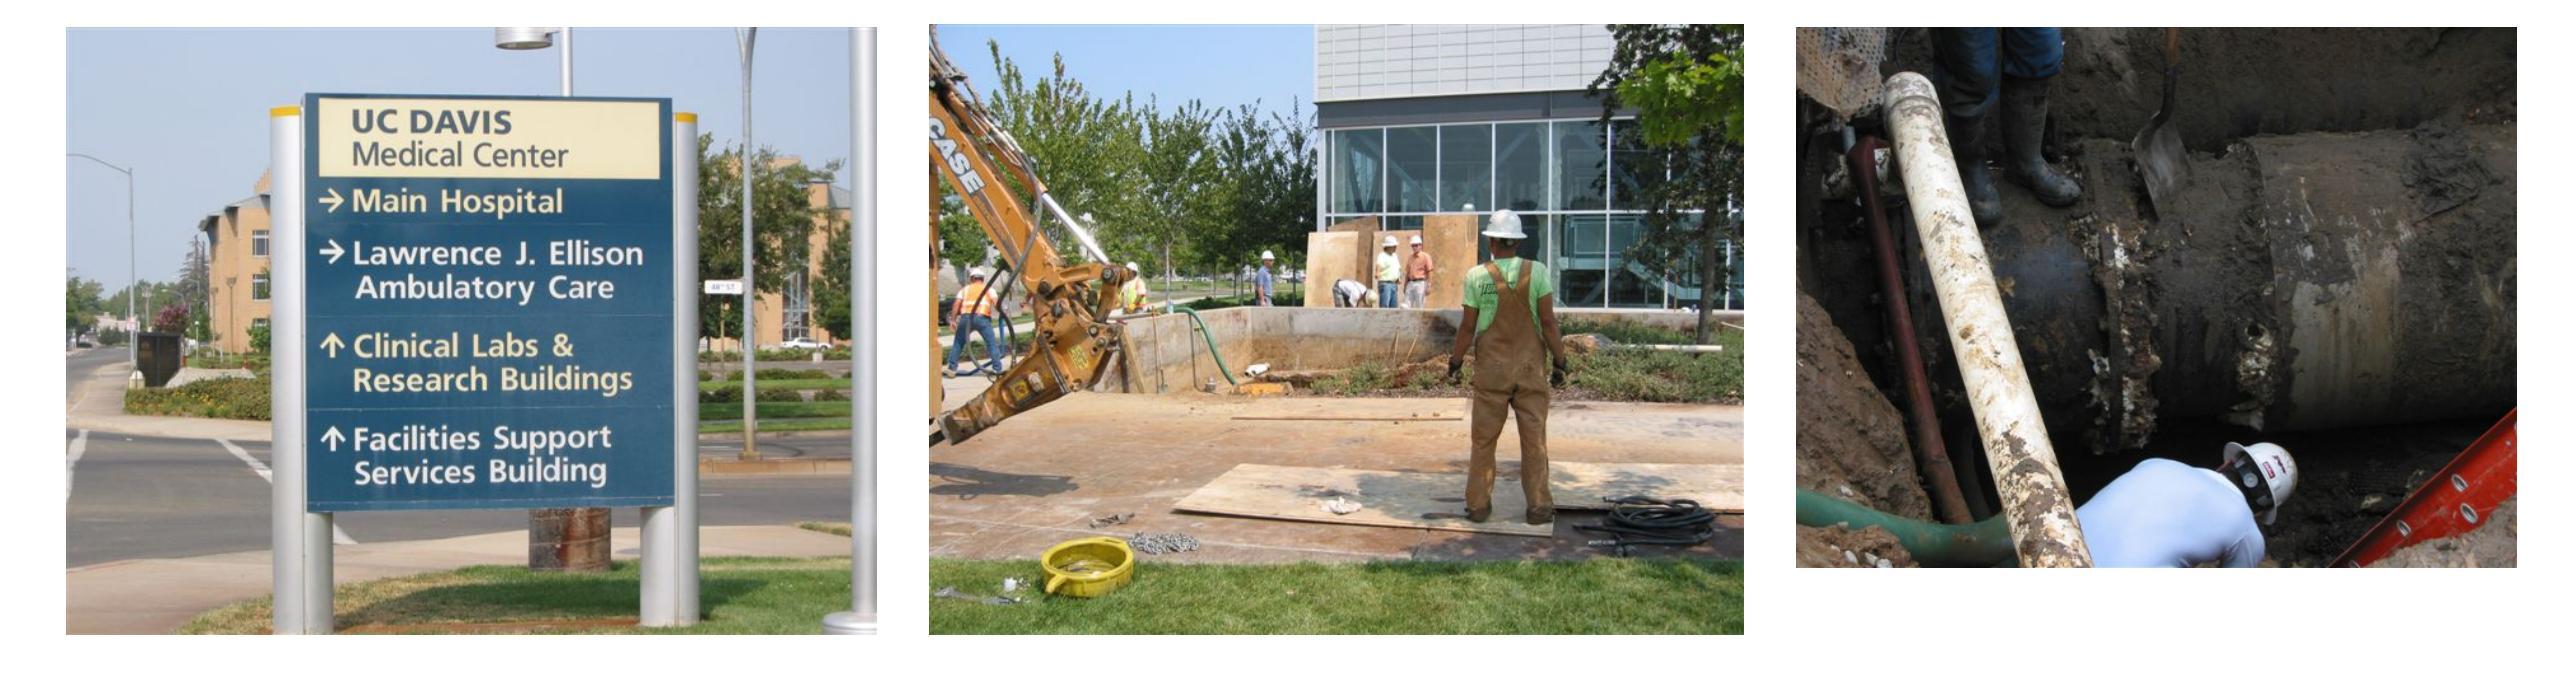
## UC Davis excavation site for repair of 30" Ductile MJ x MJ Adapter. Installation of JCM 114 Bell Repair Sleeve.
